Cost Segregation Study

Property Address: 541 Anderson Hts, Charleston, WV 25314

Prepared by: Rental Write Off LLC

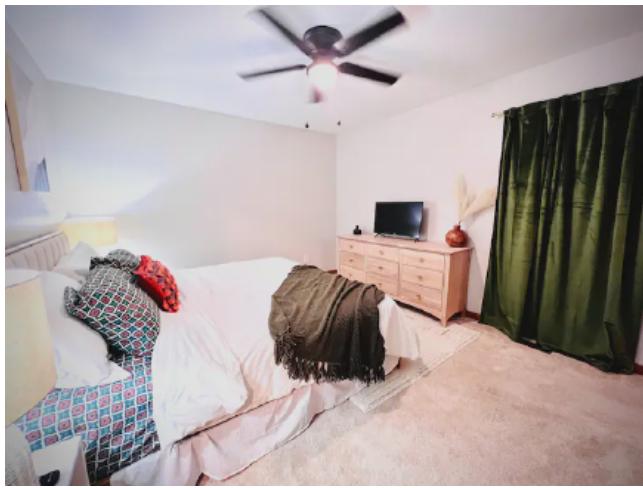
Wall-to-Wall Carpet

physical (1.0000): The beige plush wall-to-wall carpet in the bedroom appears clean, even, and free of stains, matting, fraying, or discoloration. No visible wear paths, damage, or deterioration is evident from the image. It looks well-maintained and like new, suggesting a young age of less than 2 years. Based on these visual indicators of excellent condition with no physical obsolescence, the remaining value percentage is 100%. Multiplier calculated as 1.0 (no adjustment needed).

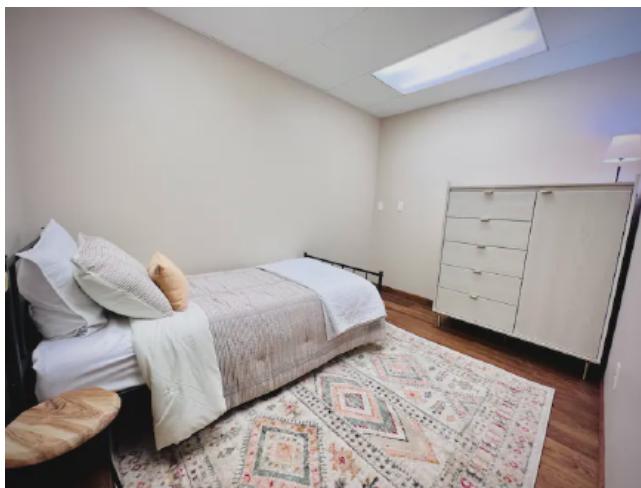
Bedding Set

physical (1.0000): The bedding set, including comforter, sheets, throw blanket, and pillows, appears to be in excellent condition with no visible signs of wear, stains, fading, or damage. It looks neatly arranged and vibrant, suggesting it is relatively new or well-maintained, with an estimated age of less than 1 year. Visual indicators such as crisp fabrics, even colors, and absence of wrinkles or frays support a like-new state. Calculation: Assigned Excellent rating, resulting in a remaining value multiplier of 1.0 (no physical obsolescence).

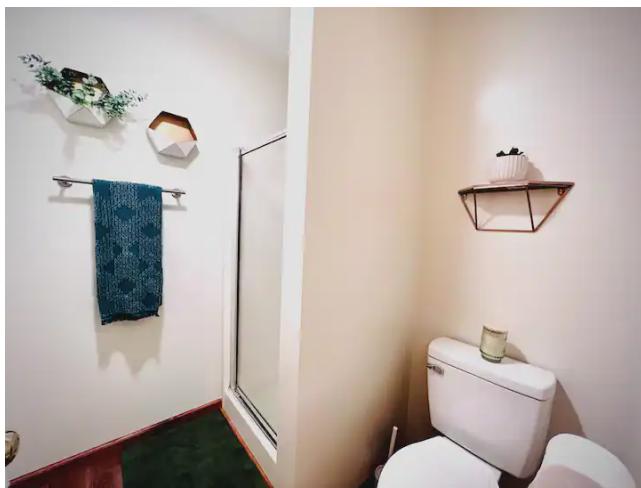
Towel bar

physical (1.0000): The towel bar is a wall-mounted metal fixture in the bathroom, appearing clean and undamaged with no visible scratches, dents, corrosion, or discoloration. It integrates well with the modern bathroom setup, suggesting limited age (likely 1-3 years) and good maintenance. Visual signs indicate like-new condition with minimal wear from use. Depreciation assessment: No significant physical obsolescence observed, remaining value estimated at 100% of original, calculated by assigning full value multiplier due to excellent condition.

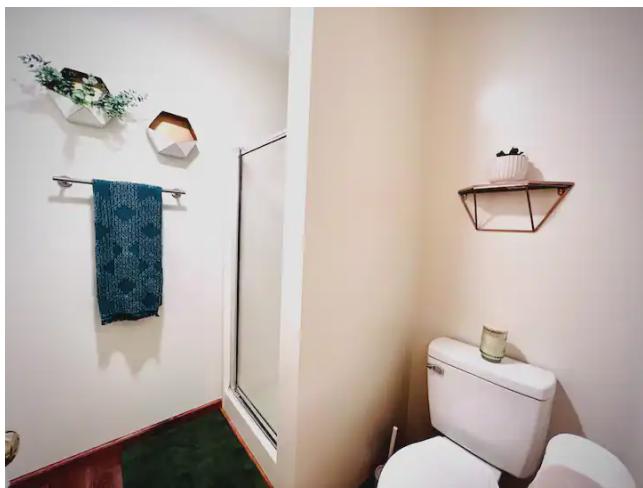
Corner wall shelf

physical (1.0000): The corner wall shelf appears to be in excellent condition with no visible signs of wear, scratches, dents, fading, or deterioration. It looks modern and well-maintained, with a plant pot placed on it indicating regular use without damage. Estimated age is recent (less than 5 years), and overall upkeep is high. No physical obsolescence observed, resulting in a full remaining value multiplier of 1.0 (0% depreciation).

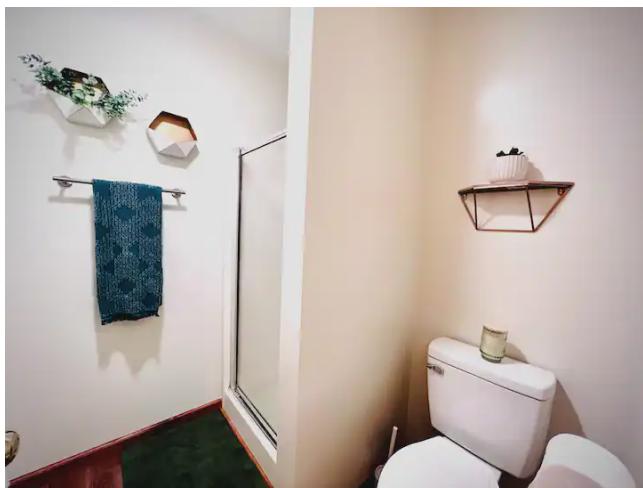
Decorative jar/candle

physical (1.0000): The decorative jar/candle on the toilet tank lid appears to be in excellent condition. It shows no visible signs of wear, scratches, discoloration, or damage. The glass is clear and clean, suggesting it is relatively new or well-maintained with minimal aging. As a movable decor item, its estimated age is recent based on pristine appearance. Depreciation assessment: No physical obsolescence evident, so remaining value percentage is 100%. Multiplier assigned: 1.0.

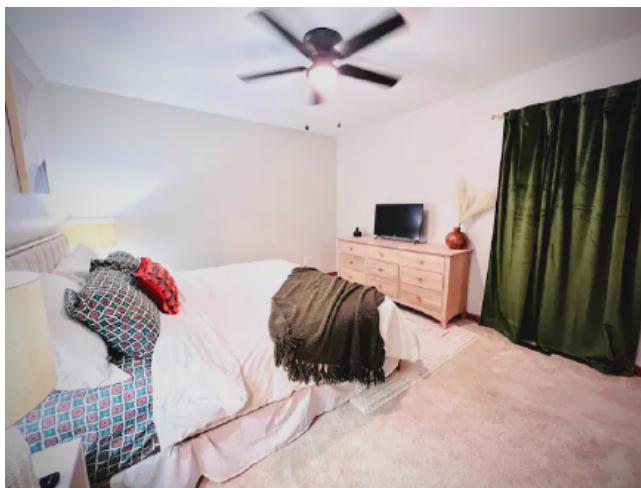
Bed Frame and Headboard

Classification: 5-year
Category: furniture
Quantity: 1 each
Description
Upholstered bed frame with tufted headboard

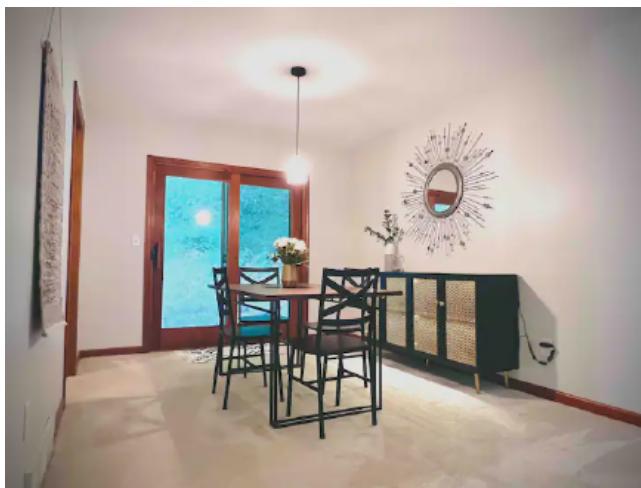
Window Curtains

Classification: 5-year
Category: window treatments
Quantity: 1 each
Description
Sheer curtain panels on sliding glass door

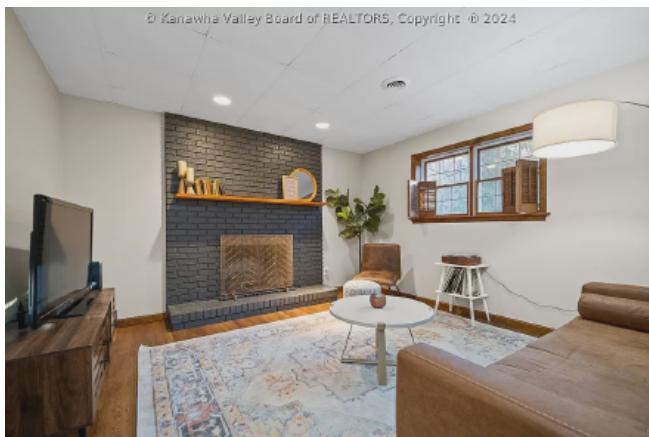
Window Shutters

physical (0.8000): The window shutters appear to be in good condition based on the image. They show no visible signs of significant wear, scratches, dents, corrosion, or deterioration. The wooden louvers are straight, clean, and intact, suggesting normal aging for interior use with evidence of upkeep in a well-maintained room. Estimated age is moderate (5-10 years), but fully functional. Multiplier calculated as 0.8 for Good condition, reflecting 80% remaining value due to minor expected wear without impact on utility.

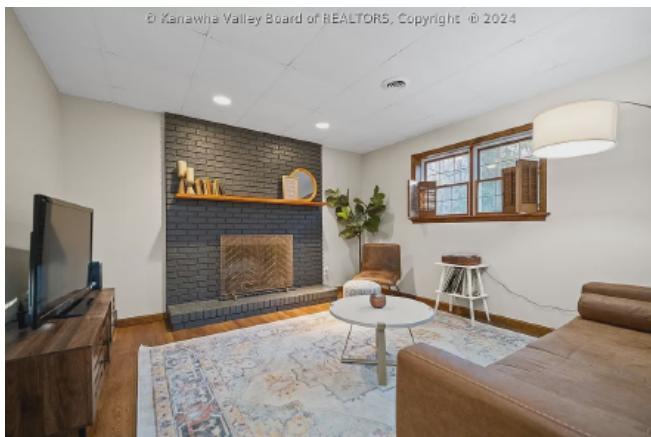
Coffee Table

physical (1.0000): The coffee table appears to be in excellent condition, showing no visible signs of wear, scratches, dents, or discoloration. It looks relatively new based on its clean white surface and sturdy appearance in a well-maintained room. Age is estimated as recent (likely less than 2-3 years), with no evidence of deterioration or damage. Depreciation assessment: Full remaining value, no physical obsolescence observed, calculated as 100% of original value (multiplier 1.0).

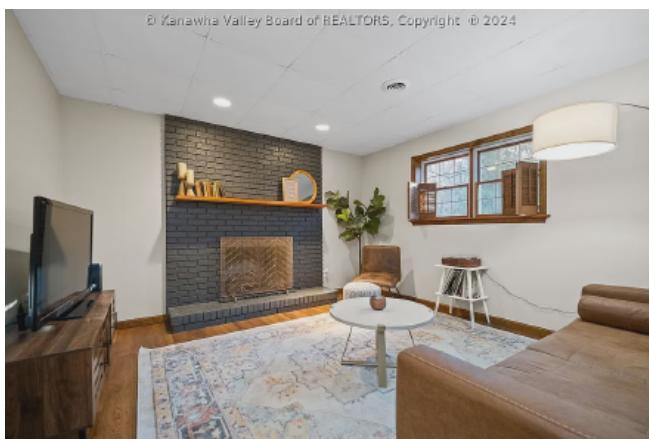
Floor Lamp

physical (1.0000): The white arc floor lamp with fabric shade appears to be in excellent condition, showing no visible signs of wear, scratches, dents, fading, or discoloration. The shade is pristine, the structure is straight and stable, and it looks recently purchased or well-maintained, consistent with a modern interior. Based on its like-new appearance and lack of deterioration, it exhibits minimal physical obsolescence. Age is estimated as under 5 years. Multiplier calculated as 1.0 (100% remaining value) per the Excellent condition rating guidelines, indicating full value retention with no depreciation adjustment needed for physical condition.

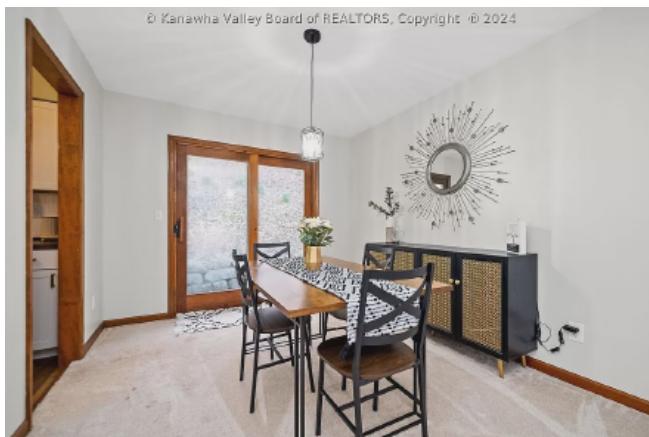
Table Runner

physical (1.0000): The black and white patterned table runner appears to be in excellent condition. Visual inspection shows no signs of wear, tear, fading, stains, or fraying. The colors are vibrant, and the fabric looks smooth and well-maintained, suggesting it is relatively new or minimally used. There are no indications of aging or deterioration. Based on the condition rating system, this corresponds to an Excellent rating with a remaining value multiplier of 1.0, as it exhibits little to no wear and is fully functional.

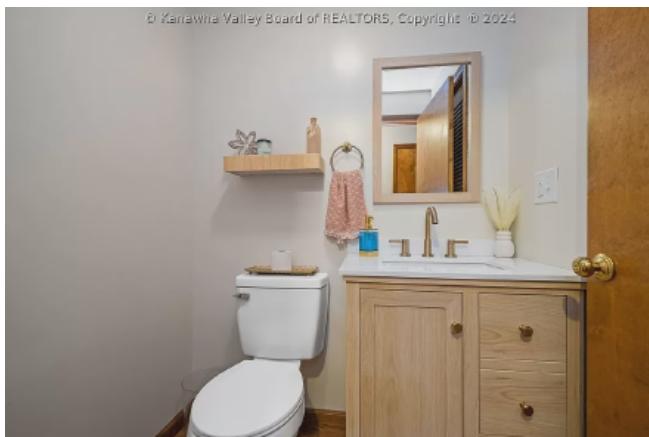
physical (1.0000): The Bathroom Vanity Cabinet appears to be in excellent condition with no visible signs of wear, scratches, dents, discoloration, or damage. The light wood finish is clean and intact, doors and drawers function normally without sagging or misalignment, and the integrated countertop shows no cracks or stains. Based on visual assessment, the item looks relatively new, estimated age of less than 5 years, with proper maintenance evident. No physical obsolescence is observed. Calculation: Multiplier of 1.0 applied as the item is like new, retaining 100% of its value percentage for depreciation purposes.

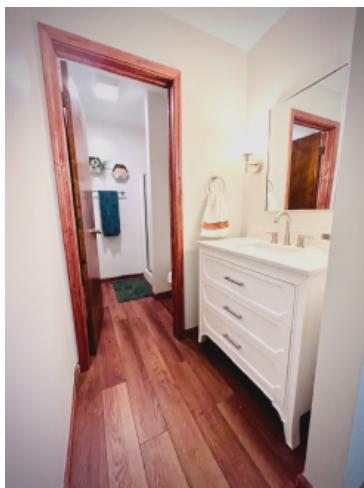
Towel Bar

Classification: 5-year
Category: fixtures
Quantity: 1 each
Description
Wall-mounted metal towel bar

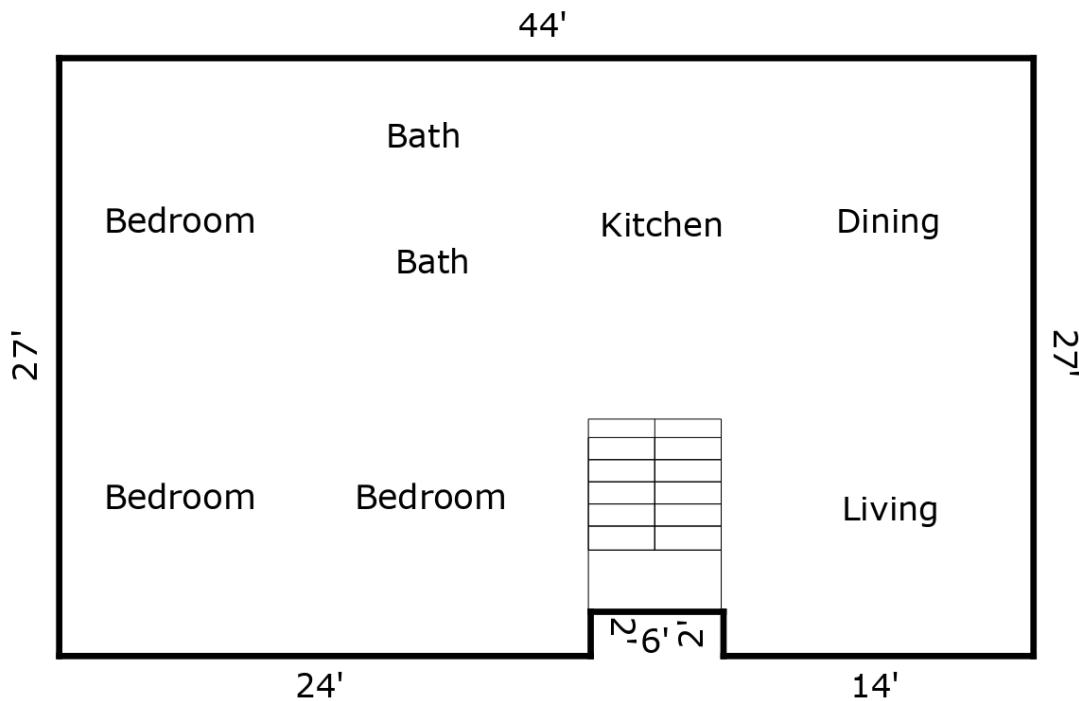
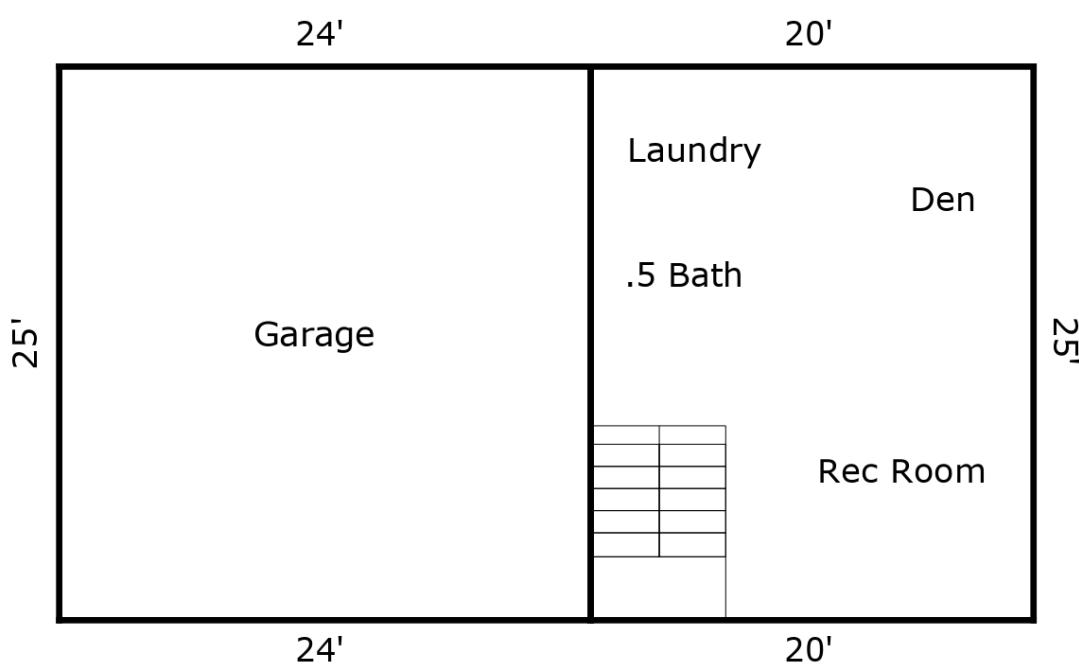
Building Sketch

Area Calculations Summary
